**CULTURAL RESOURCES OFFICE  
PRESERVATION BOARD  
REGULAR MEETING  
MONDAY NOVEMBER 26, 2012 — 4:00 P.M.  
1520 MARKET ST. #2000  
[www.stlouis-mo.gov/cultural-resources](http://www.stlouis-mo.gov/cultural-resources)**

**DATE:** November 26, 2012  
**FROM:** Betsy Bradley, Director, Cultural Resources Office  
**SUBJECT:** Preliminary Review to demolish existing 5-story building  
**ADDRESS:** 1105-09 Olive  
**JURISDICTION:** Preservation Review District — Ward 7

1105-09 OLIVE

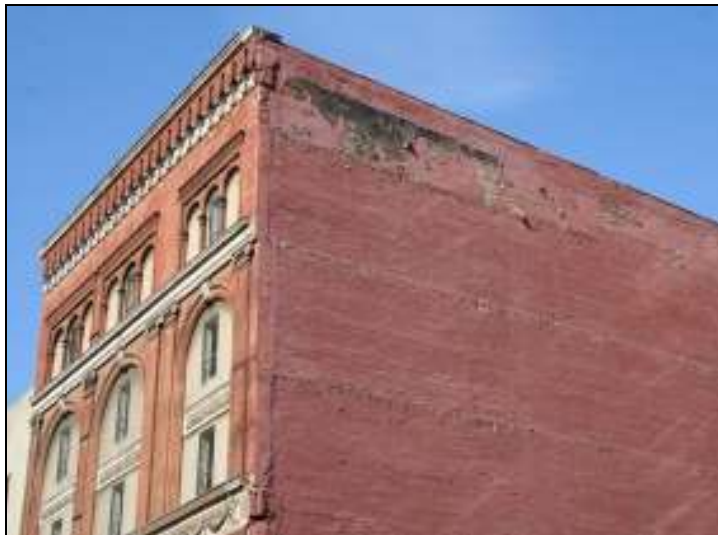
UPPER PORTION OF EAST WALL

**Ordinance #64689 defines “sound” to mean that visible portions of exterior walls and roofs appear capable of continuing to support their current loads for six months or more. The exterior inspection of the building indicates that it meets this definition of soundness. The upper stories of the Olive façade attest to the quality of the brick and masonry craftsmanship and display few indications of loss of masonry elements or needed maintenance. The exposed party wall exhibits water damage near the top of the south side; parapet coping is missing and so water damage continues. Overall, this wall needs maintenance and repair: at a minimum, repointing and perhaps some brick relayment. One opening in the east wall, which has been closed with recessed brick, has lost several unsupported voussoirs from its rowlock arch, a condition that does not appear to be recent. The east bay of the**

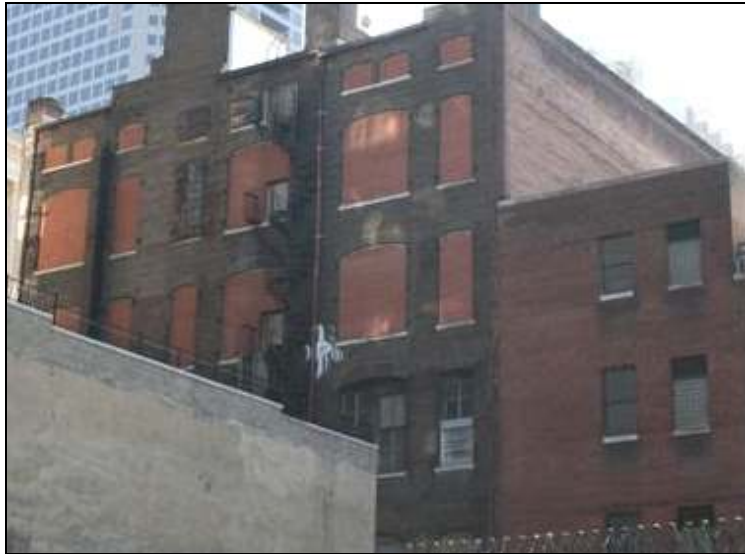
UPPER PORTION OF NORTH WALL

north wall exhibits step cracks, some loss of arch brick, and evidence of earlier inappropriate re-pointing as well as a number of exposed mortar joints in need of additional repointing. The piers of the first story of the south façade, which has been reconstructed, have cracked brick that indicates that the veneer is delaminating from the substrate. These conditions are evidence of deferred maintenance and perhaps destabilizing conditions, but do not suggest that the building cannot stand for another six months.

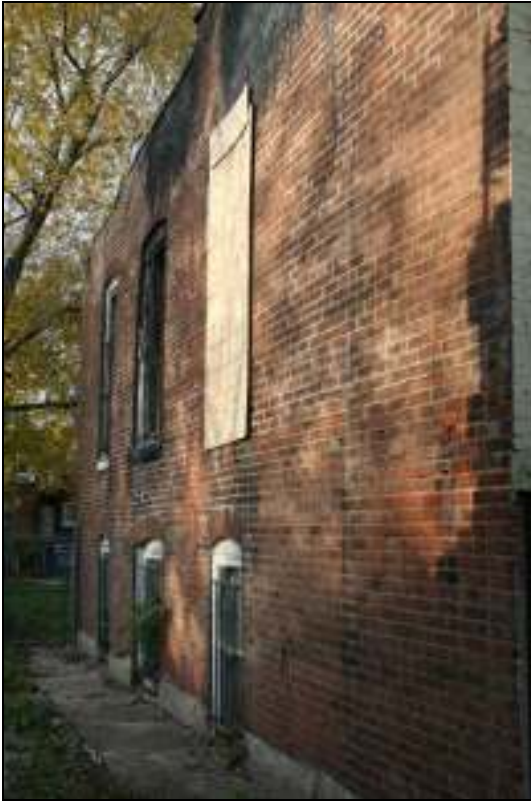
**EAST ELEVATION FIRE DAMAGE**

**The building is sound under the definition of the ordinance. The building has received some fire and water damage from the fire that occurred next door. This damage has exacerbated bowing issues of the east wall already present before the fire. Scorching at the roof line indicates possible damage to the roof structure. In addition, there was some preexisting bowing of the west wall of the building, unrelated to the fire.**

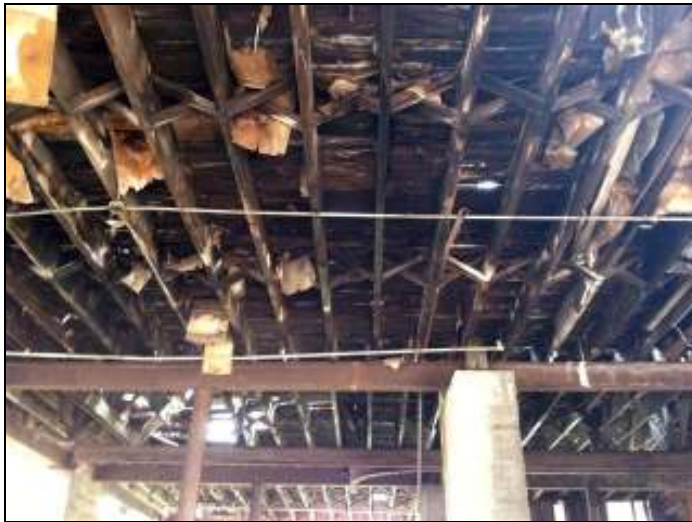
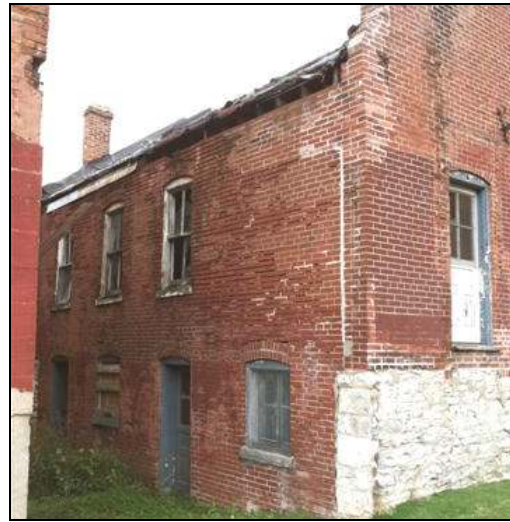
**EVIDENCE OF ROOF DAMAGE ON THE FACTORY BUILDING (LEFT) AND HISTORIC HOUSE**

The factory building has been open to the elements for many years. The rear gutter failed long ago, allowing water to penetrate between the wythes of brick on the west wall. The roof has deteriorated to the point that sunlight is perceptible in the interior of the building at ground level. The building is not boarded and open to access at all levels.

The adjacent historic house has also significant roof damage and lacks functioning gutters and downspouts. It has some intact original window sash and is partially boarded, although the second story is open.

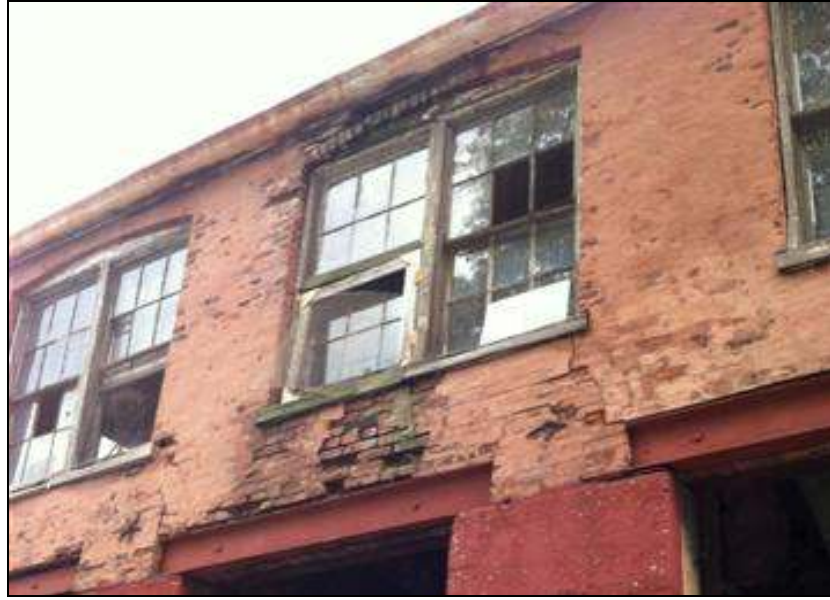
**WEST ELEVATION: NOTE MASONRY DETERIORATION AT CENTER BAY  
DUE TO MALFUNCTIONING GUTTER**

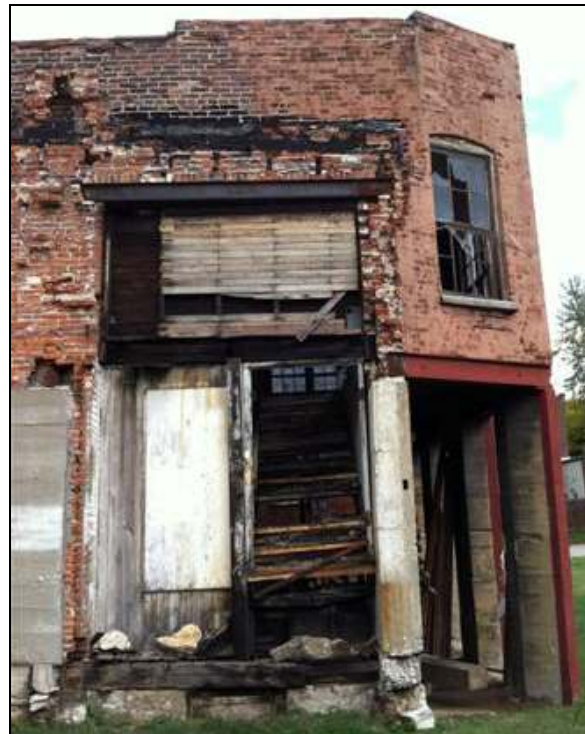
**SOUTH ELEVATION: NOTE DETERIORATED MASONRY  
AT OPENING TO SECOND FLOOR STAIRWAY**

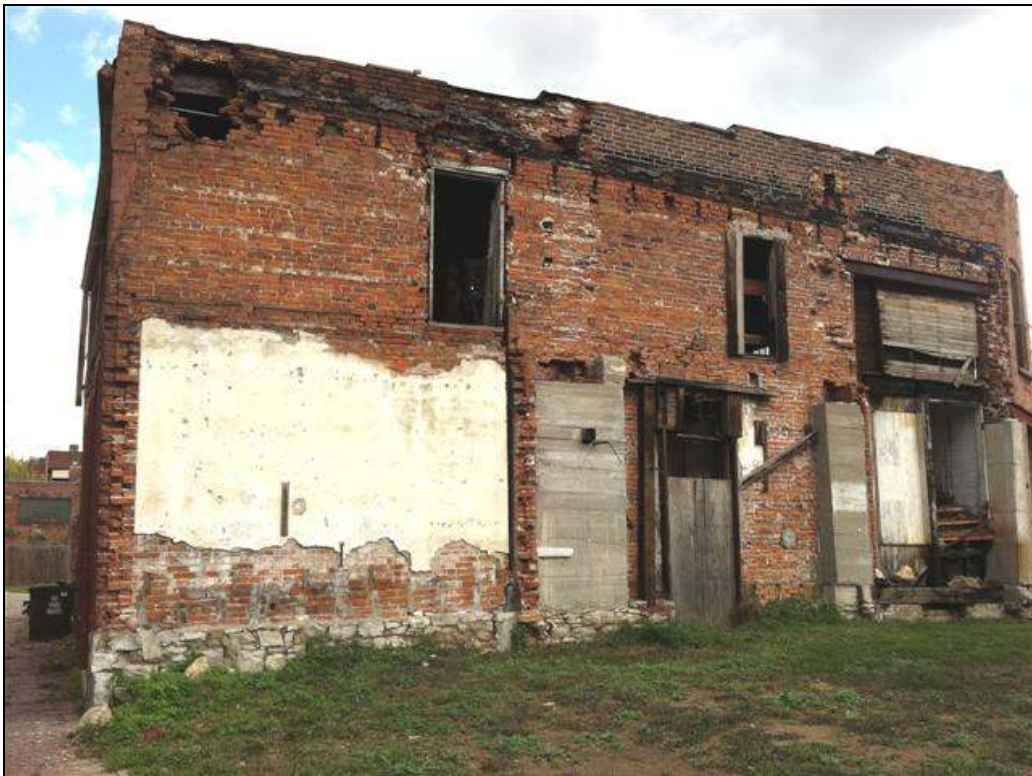
**DETERIORATED SOFT BRICK ON SOUTH ELEVATION**

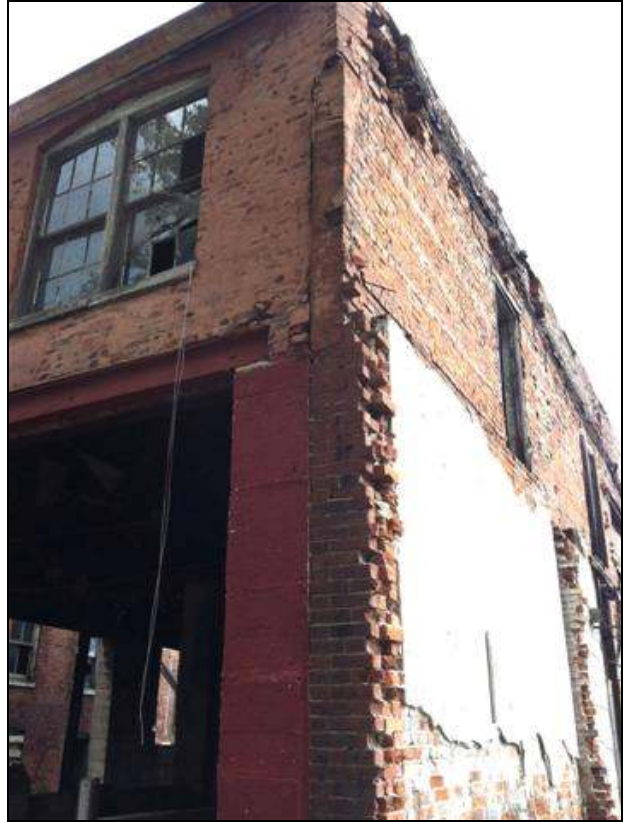
**SOUTHEAST CORNER OF FACTORY BUILDING  
NOTE STRUCTURAL CRACKS AND SEPARATION OF WALL**

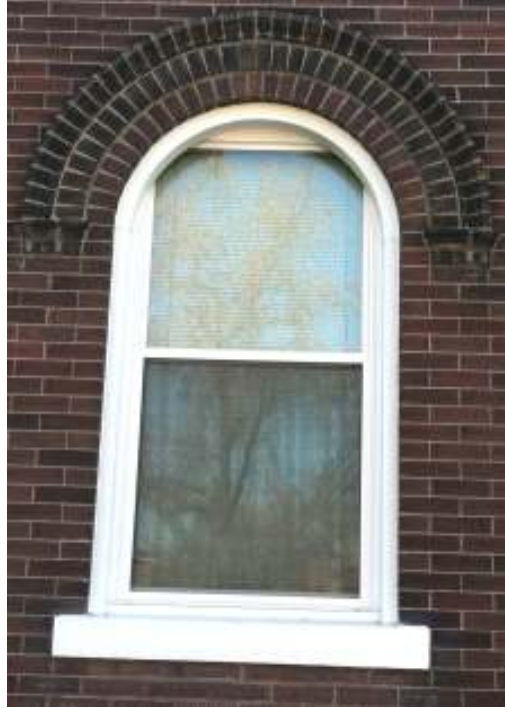
SQUARE HEAD WINDOW INSERTED WITHIN A HALF ROUND OPENING  
BRICKMOLD WRAPPED WITH ALUMINUM COIL STOCK

Aluminum coil stock has been applied to the brick mold, obscuring the original profile of the brick mold.

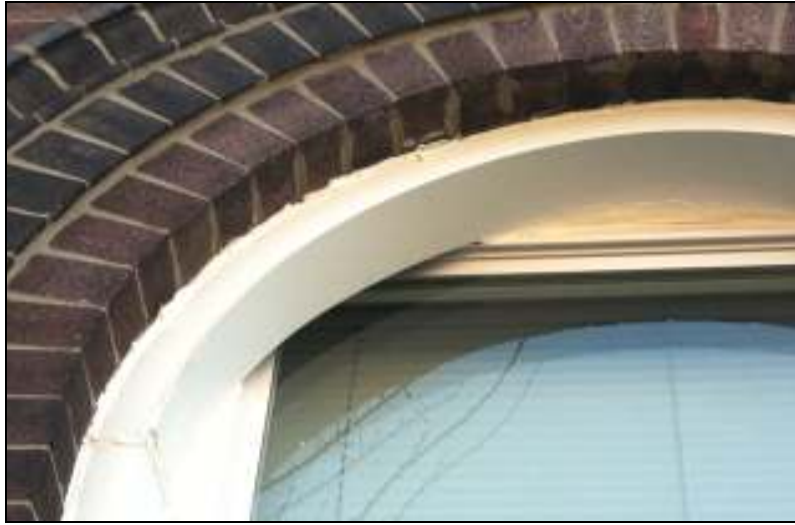
**DETAIL OF WINDOW JAMB WITH WRAPPED BRICKMOLD  
CAULKING USED TO FILL GAP AT TOP OF WINDOW**

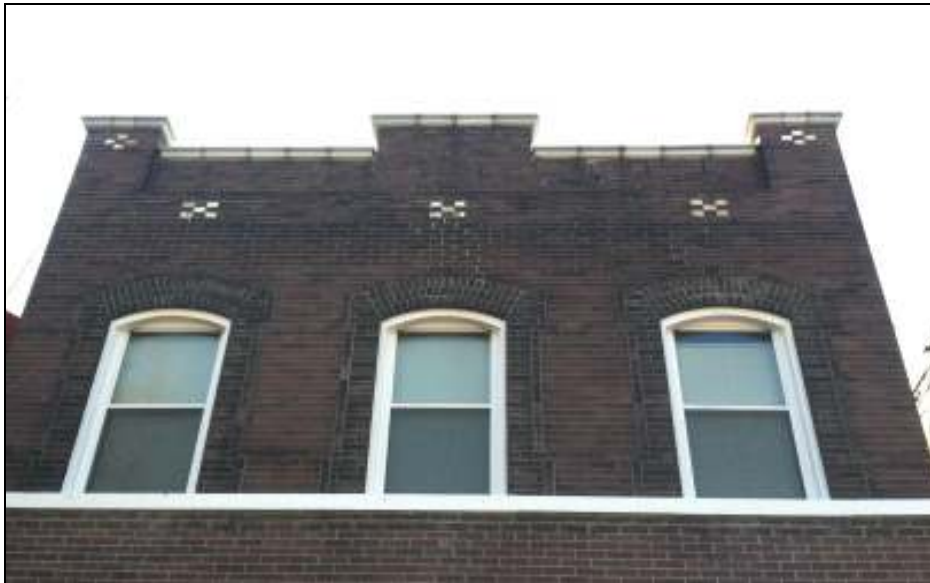
**SECOND STORY SEGMENTAL ARCH WINDOWS  
EYEBROW FORM ALTERED**

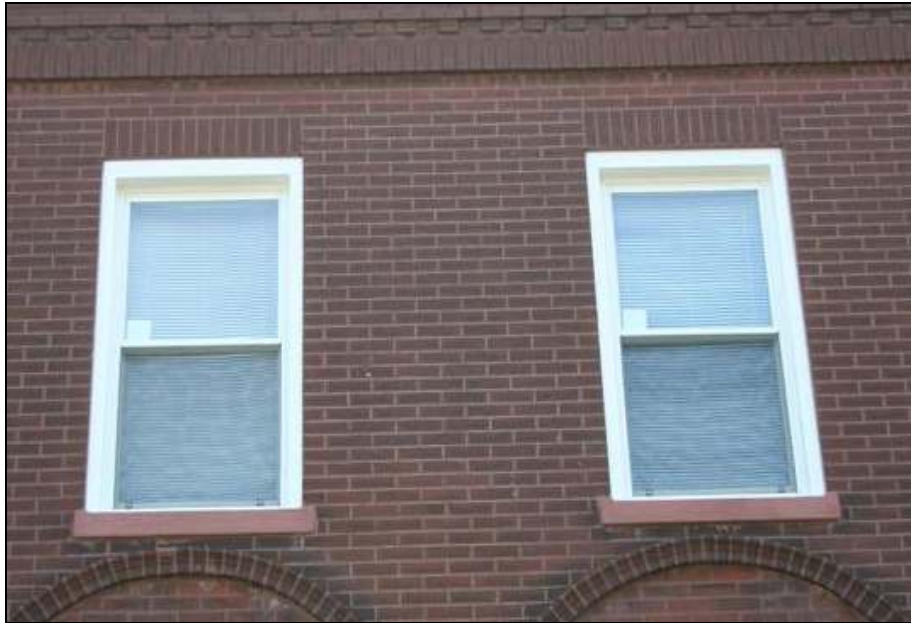
**VINYL WINDOW AT 2300 RUSSELL**

**Does not comply.** The windows are vinyl and do not match the original windows in the profiles of the muntins, sash, frames and moldings. They are single-hung instead of the double-hung sash and therefore are more flat in appearance and do not present the depth of a double-hung window. In the wider openings, the installation of a pair of windows separated by a mullion introduces a new configuration that alters the number, arrangement, and proportion of lights. The three-over-one muntin pattern of the upper sash, a distinctive detail, has not been replicated. The eyebrows, brickmold and sills have been wrapped in aluminum coil stock, concealing the profiles and moldings and further simplifying and flattening the openings' appearance.

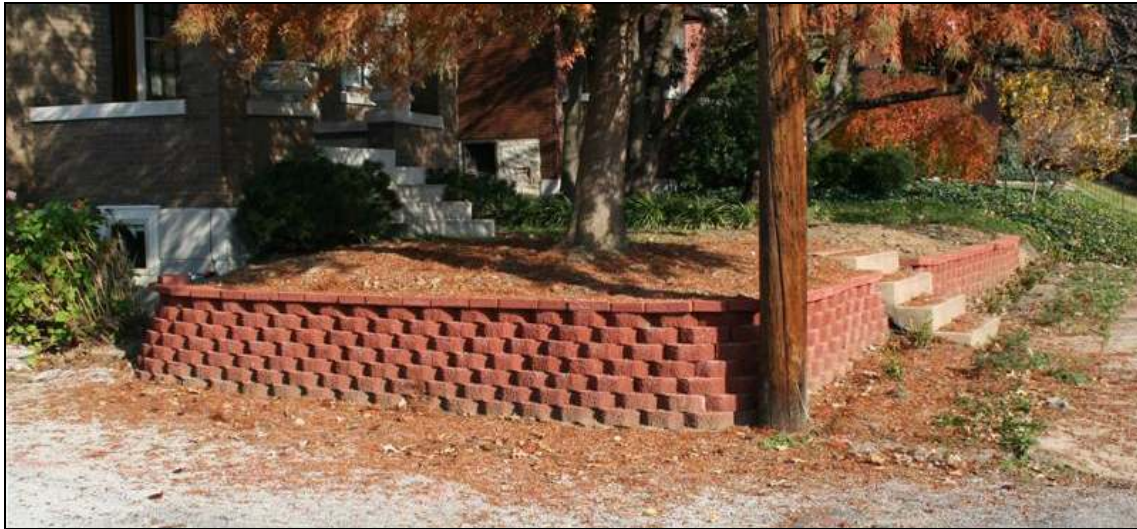
**DETAIL OF WALL LOOKING NOTHEAST**

**Does not comply.** The retaining wall is constructed out of Versa-Lok cast concrete units, a material not in the list of approved materials for construction. Natural stone, or artificial stone that has the appearance of natural stone are the appropriate materials for a retaining wall. The red color of the artificial stone and shape of the cast units have contemporary properties. These attributes are not compatible with existing historic fabric and therefore don't meet the intent of the standards for walls, fences or enclosures.
